97 The Terrace - Seismic Strengthening

Client: Cequent Projects

Consultant: Bluebarn Engineers

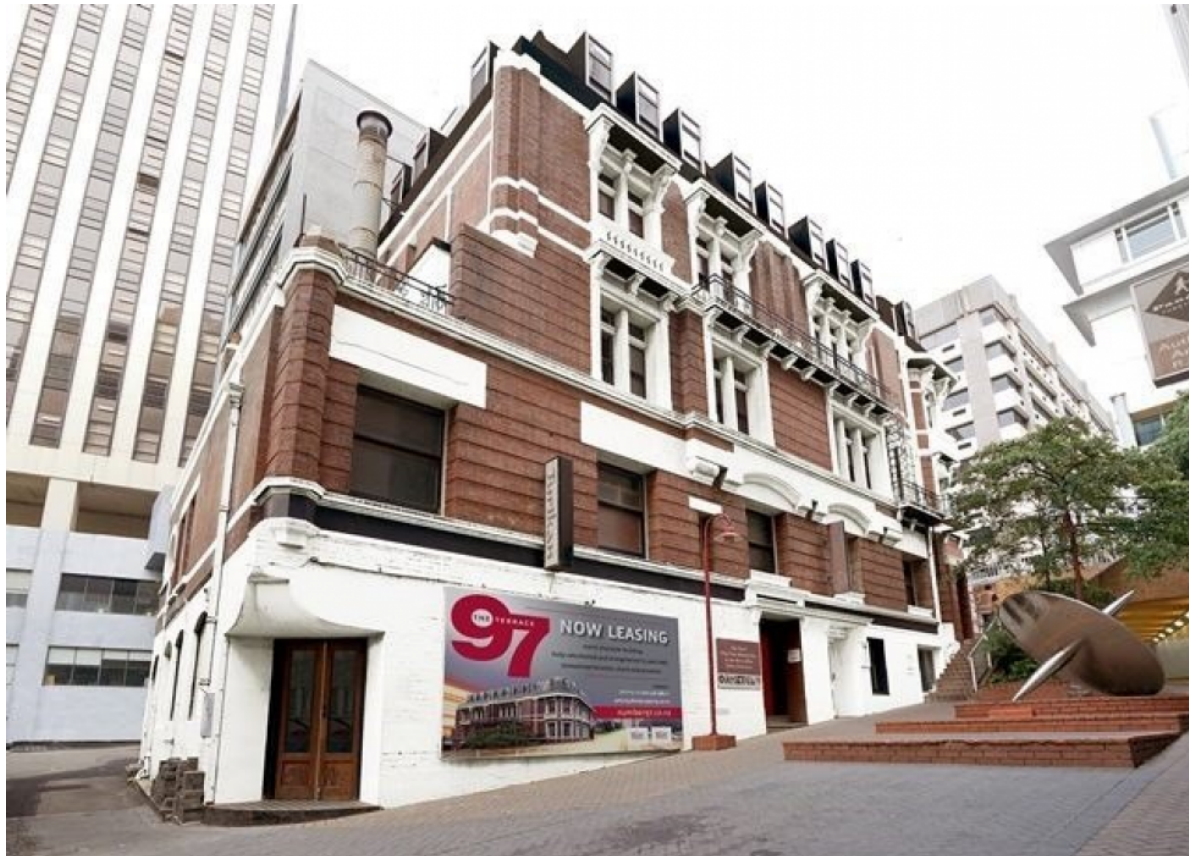
After the Kaikoura Earthquake of November 2016, a 130 year old four storey brick building in the Wellington CBD was to undergo major seismic strengthening to bring it up to the New Building Standard.

It had its floors and balconies demolished and new floor slabs poured, together with the life shaft constructed.

Freyssinet were engaged to strengthen the perimeter walls with the use of Freyssibars anchored within the brick wall in the basement floor.
