Golden Bay Cement Silos - Major Remedial

Client: GBC Winstone

Type: Design and Construct

Location: Northland

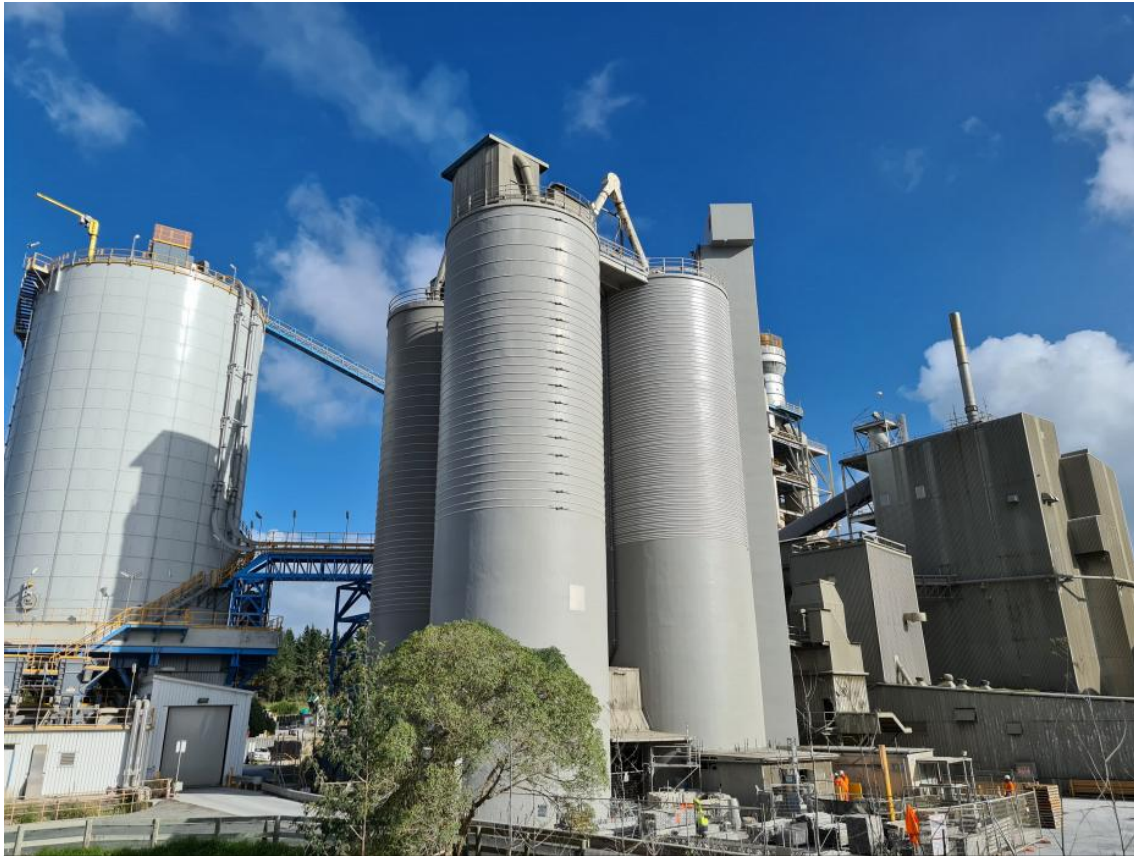
In 2015, Freyssinet were commissioned to do a condition assessment on one of the concrete silos. The silos were deteriorated to the point that they had reduced capacity to avoid failure. Other consultants had concluded that the silos could not be salvaged, until Freyssinet came up with a repair strategy that enabled not only to reinstate full capacity, but to extend the life of the silos but another 25 years.

The full scope of works across five silos included access solutions and management through scaffolding, coating removal using water-jetting, concrete breakout, steel augmentation, dry-spray concrete, elastomeric coating, and strengthening through additional post tensioning, using the 1X15 system.
