# **Taita Reservoir - Seismic Strengthening**

**Client:** Wellington Water

**Consultant:** WSP Opus

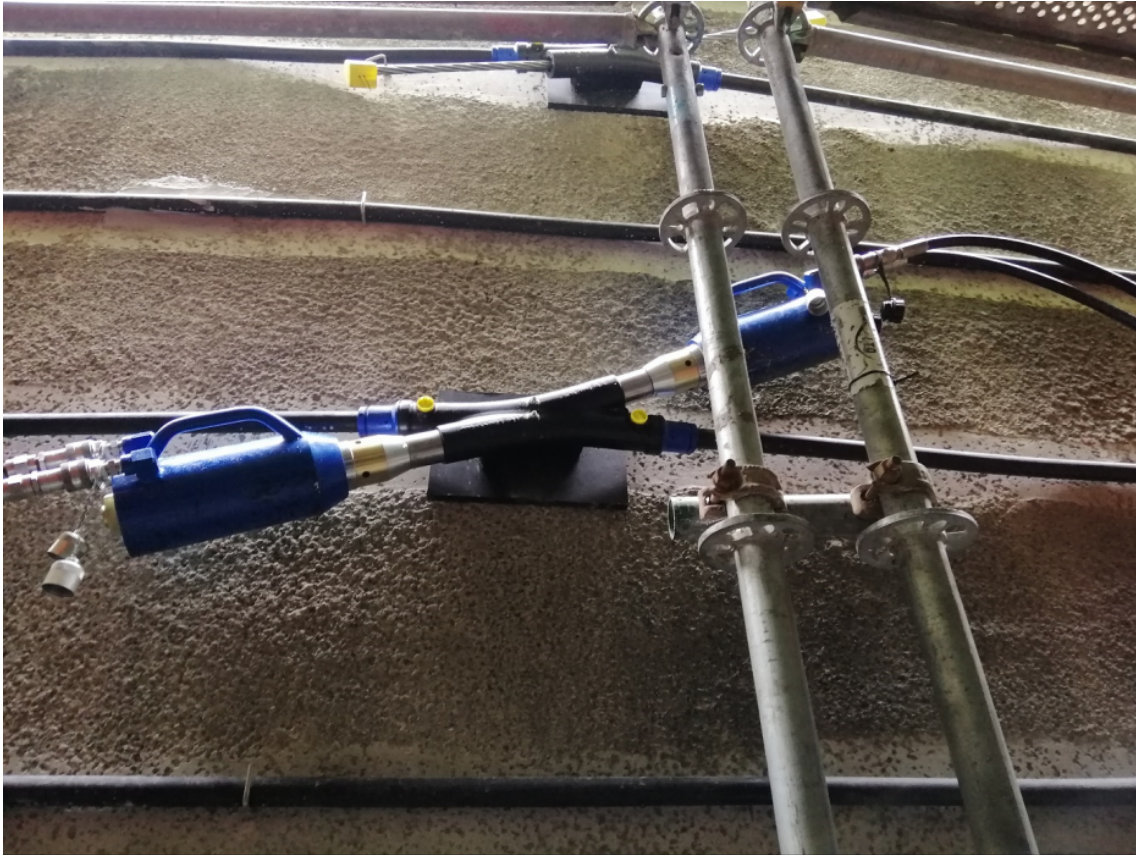
Taita Reservoir is located in Upper Hutt, Wellington. It is a concrete water tank, 34m in diameter, 104m circumference, and 7.2m high with a dome roof. The whole structure underwent seismic strengthening due to poor overall condition and major leaks.

Freyssinet were engaged to perform the post-tensioning works of the watertank and were responsible for the supply and installation of:

- 10no. Freyssinet 1x15 external prestressing anchorages
- 1100m of greased and sheathed 15.7mm galvanised strands with 279kN minimum breaking load
- 1100m HDPE duct

Followed with grouting and stressing with monostrand jacks and greasing of all anchorages to provide anticorrosion measures. Prior to installation, all undulations on the surface of the watertank had to be levelled and evened off.
