# **Tawa Reservoir - Seismic Strengthening**

**Client:** Wellington Water

**Date:** October, 2016 to January, 2018

**Location:** Wellington

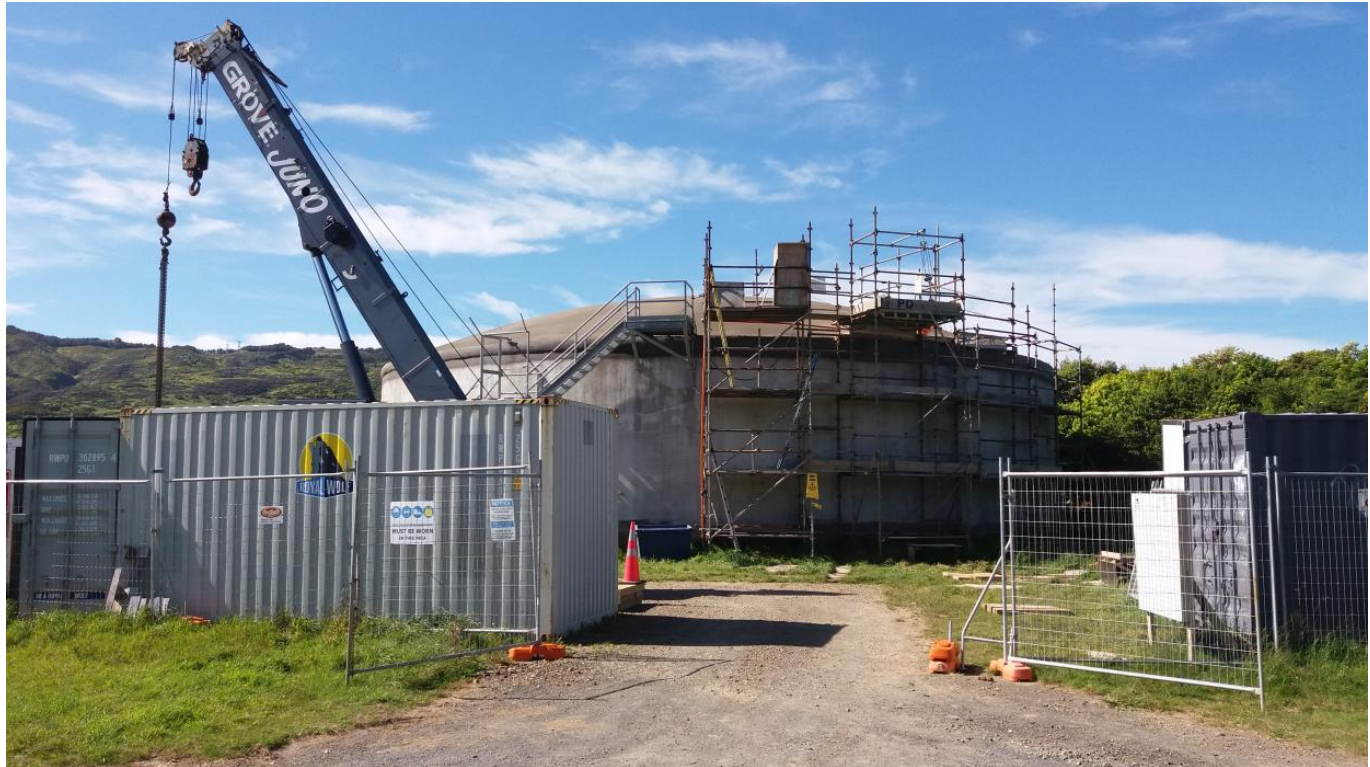
24m in diameter and 6m high with a dome roof, Tawa Reservoir is a concrete water tank in Wellington.

The whole structure was to undergo seismic strengthening due to overall poor condition and leaks. The original scope for this project was to install FRP wrap around the perimeter, pour overlay concrete slab and roof topping, and application of waterproofing layers to the roof and internal walls. Due to the major seismic event in November 2016/7, some of the original scope was removed leaving the overlay concrete slab and all the waterproofing.

Remediation of steel pipework and installation of handrails were added to the original scope.
